# Localised Galvanic Corrosion Processes in Thermal Spray Coated/Cast Aluminium Alloy systems

D. Culliton<sup>a</sup>, A. Betts<sup>b</sup>, D. Kennedy<sup>a</sup>

**SUMMARY :** Cast Aluminium Alloys, because of the propensity of aluminium to react with impurities and alloying elements, are prone to developing IM impurities during the solidification process. These IM phases can act, in some fluids, as initiation sites for localised corrosion processes, resulting in degradation phenomena, such as pitting. Whilst Thermal Spray coatings can improve the wear resistance of Cast Aluminium Alloys, their corrosion performance may be hampered by the presence of through porosity within the coating.

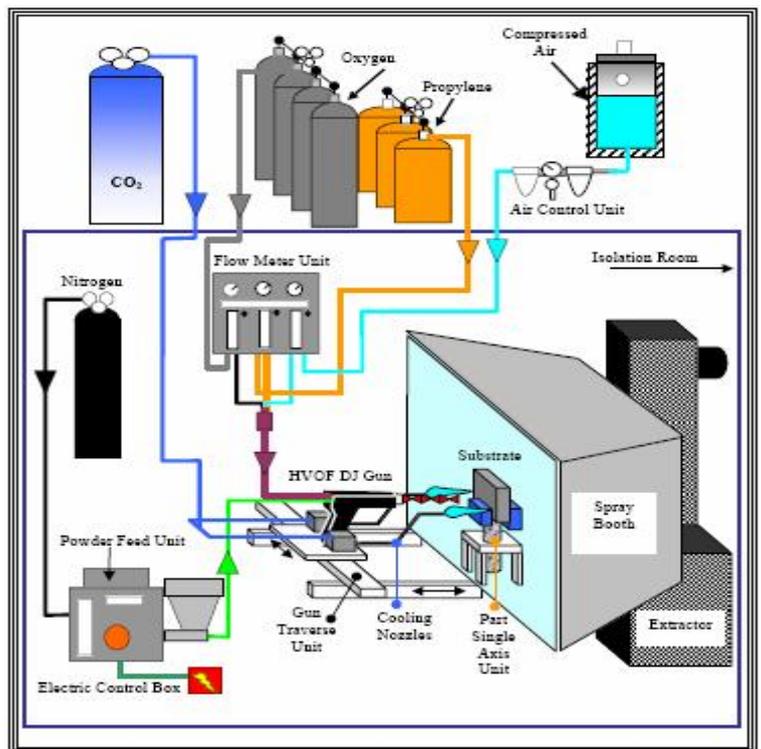
Figure I Thermal Spray (HVOF) application system

Prior to the coating, the panels were first sand blasted using alumina grit, to remove surface contaminants and provide a key for the Thermal Spray coating. The coatings were then applied using the HVOF Thermal Spray system (Figure I).

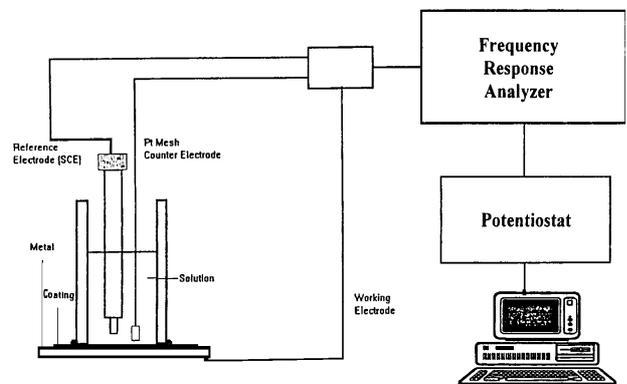
Figure II Schematic of the setup for Electrochemical Impedance Spectroscopy testing.

EIS is an electrochemical technique that enables the real time behaviour of coatings on metallic alloys to be assessed. The development of various processes, such as diffusion of water through a coating and the onset of corrosion, are progressively reviewing over a period of time, during which the coating is exposed to an environment containing corrosive chemicals - including acids, alkalis and chlorides and/or sulphate species. The electrochemical cell normally used in EIS experiments comprises a three electrode system (Figure II).

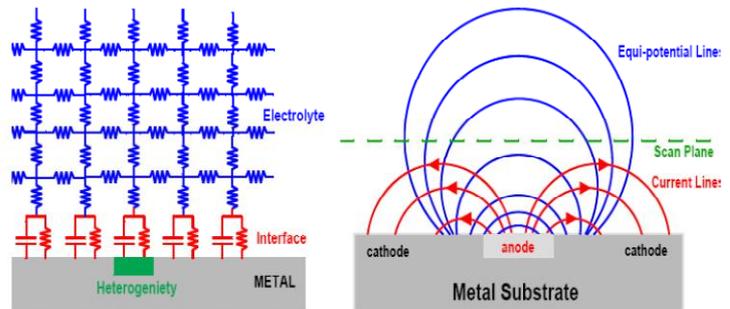
Figure III Illustration of a resistance model for a reactive surface in an electrolyte and the equivalent equipotential lines.

In aluminium alloys, corrosion is a highly localised process. General corrosion measurement techniques can quantify bulk process parameters but localised galvanic processes require a dynamic measurement technique, such as either the Scanning Resistance Electrode Technique(SRET) or SVET. Representation of the functionality of SVET system is displayed in Figure III<sup>12</sup>. SVET, a development of SRET, provides a lower detection limit and higher resolution and, under controlled conditions, can be used to indicate the evolution of pitting with time<sup>13</sup>. Instead of the dual probe arrangement used in SRET, SVET incorporates a solitary electrode which vibrates perpendicular to the surface, using a piezoelectric vibrator. The potential distribution within the electrolyte above the surface (30-100 $\mu\text{m}$ ) is measured using a single electrode vibrating between two points and the potential is recorded at the highest and lowest probe position, resulting in a sinusoidal AC signal. Signal processing is performed using a lock-in amplifier and a differential electrometer. The lock-in amplifier, set to the frequency of vibration, clears the signal by filtering out noise from all other frequencies. The detection limit and resolution is improved considerably by using a vibrating probe instead of a stationary dual probe. Probe vibration amplitudes, typically 1 $\mu\text{m}$  to 100 $\mu\text{m}$ , decreases the magnitude signal observed with respect to the SRET, but due to an increased signal to noise ratio achievable by use of a lock-in amplifier and signal averaging, low current measurements in a minimal time can be achieved with a detection limit, for the SVP100, to be below 5 $\mu\text{A}/\text{cm}^2$ .

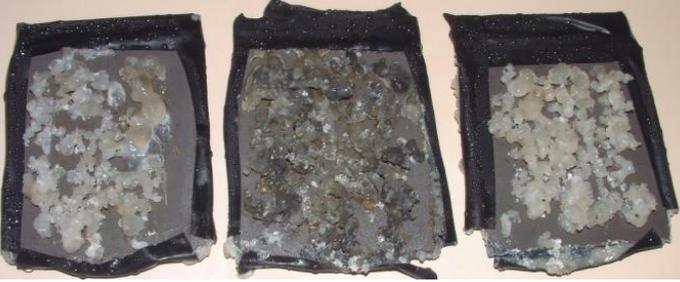
<p>HVOF – SS317L 96 hours exposure</p> <p>Extensive Corrosion product apparent after 24 hours.</p>

Figure IV Test Panels after exposure in the Acidified Salt Spray test

Figure IV show the test panels from the Acidified Salt Spray Test. Each set were tested for a full 1000 hours and the purpose of this test was to expose the coating systems to a high-humidity, chloride environment. However, the photographs were taken at the point of failure of the coating systems. The Inconel 625 and SS317L panels showed degradation after only 24 hours of exposure- Figure IV(a,b). The corrosion product appeared as blistering over the exposed surface. Figure IV(c) shows the 316L panels after 1000 hours exposure. It can be seen that no degradation of the surface occurred on these panels.

the cathodic areas provided by the coating, and the anodic tip provided by the substrate. The accelerated corrosion process that ensues is further compounded by the production of the voluminous corrosion product, preventing a retardation of the cathodic reaction. In Figure X and Figure XI we can see that the results of this effect. Figure X shows the EIS results of the SS317L coating. It can be seen that the initial  $R_p$  is approximately equal to that of the uncoated panel ( $2 \times 10^2 \Omega cm^2$ ). However, this value drops dramatically over the life of the test ( $0.2 \times 10^2 \Omega cm^2$  after 24 hrs). The presence of the more cathodic Ni and Cr create large cathodic areas to the highly anodic Al substrate. In Inconel 625, the high levels of Ni and Fe provide the cathodic impetus for these aggressive corrosion processes. Figure XI gives the results of the Inconel 625 coating, over periods of 0 to 30 hrs, showing similar reductions in the  $R_p$  value [ $2 \times 10^2 \Omega cm^2$  @ 0 hrs to  $1 \times 10^2 \Omega cm^2$  at 30 hrs]. It can be seen that there is a slight increase in the  $R_p$  value between 2 hrs and 30 hrs. This is attributed to the corrosion product acting as a barrier to the corrosive electrolyte. The physical manifestation of these corrosion processes are demonstrated in Figure IV(a)[SS317L] and

Figure IV(b)[Inconel 625].

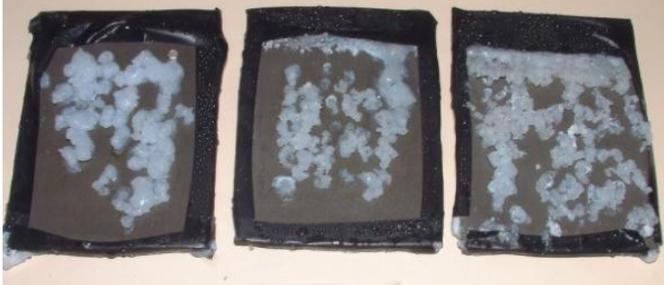
<p>HVOF – Inconel 625 96 hours exposure</p> <p>Extensive Corrosion product apparent after 24 hours.</p>

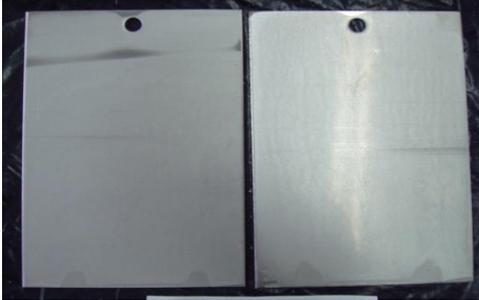
<p>316L 1000 hours exposure</p> <p>No change to the surface morphology was noted.</p>

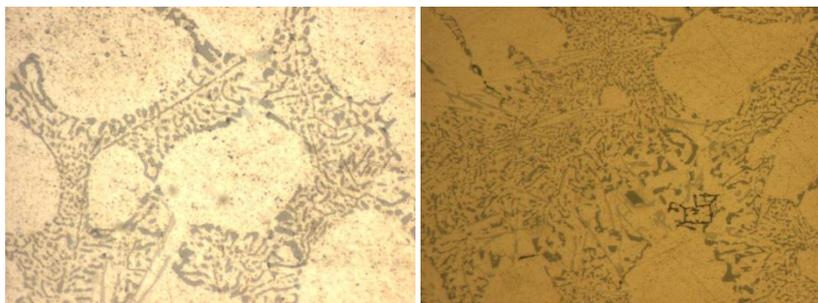
Figure V Photomicrographs showing typical microstructure of LM25/A356 Al-Si Alloy (mag. x500).

iron and modify this phase to less harmful morphologies. Typical microstructures of the LM25 alloy under investigation are shown in Figure V, exhibiting this Chinese Script structure, with the dendritic aluminium grain growth dispersed within a eutectic Al-Si structure. Process-related porosity was not noted on any of the samples viewed.

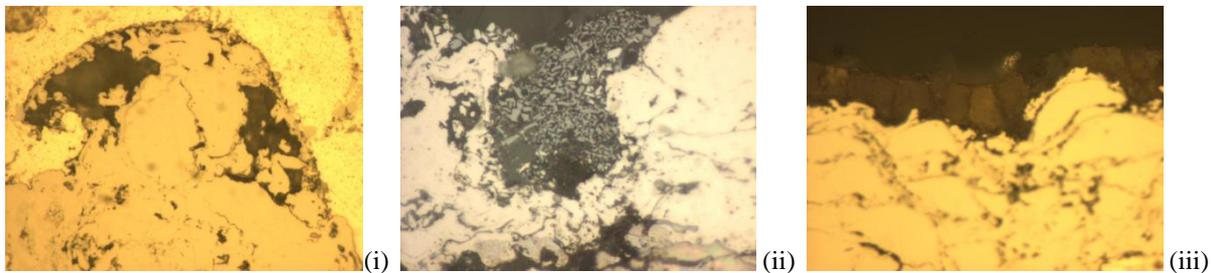
**Figure VI** Cross section photomicrographs showing the degradation of the SS317L HVOF coating in the ASS environment. (i) x500, (ii) x200; (iii) x200

increasing the corrosion rate. On the Inconel 625 and SS317L coatings, corrosion was noted after only 24 hours. Figure VI shows the degradation of the SS317L coating system after exposure in the ASS environment. The dissolution of the alloy beneath the coating, by Pitting Corrosion, Figure VI(i,ii), and the subsequent growth of the oxide layer, Figure VI(iii), resulted in spalling of the protective coating, as shown. This pitting is caused by breaches in the coating as a result of through-pores, which are a generic problem with Thermal Spray coatings. This is followed by the accumulation of Cl<sup>-</sup> ions at the surface and this accumulation actively breaks-down the oxide layer and prevents growth of a new oxide layer. Once the oxide layer has broken down, corrosion of the substrate proceeds by the dissolution of the aluminium matrix Fe-containing phases, as these phases are cathodic to the surrounding matrix. Similar effects can be seen for the Inconel 625 in Figure VII.

2. Metallographic inspection showed delamination of the coating at areas of corrosive attack. The growth of the corrosion product at the substrate/coating interface resulted in further spalling and degradation of the coating, further exposing the unprotected substrate to attack.

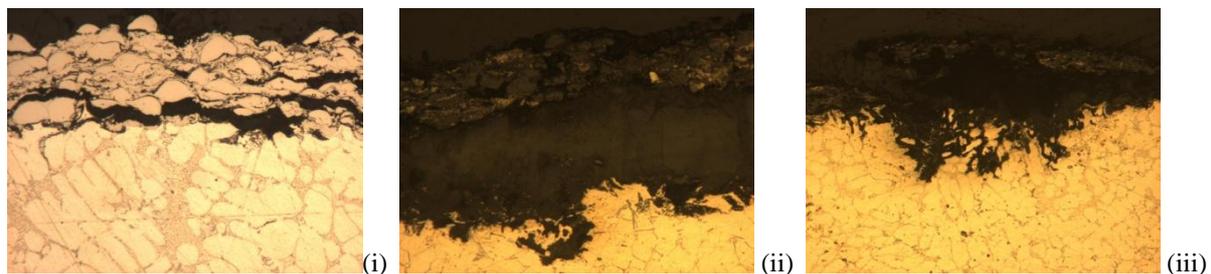
**Figure VII** Cross section photomicrographs showing the degradation of the Inconel 625 HVOF coating in the ASS environment. (Mag. x200)

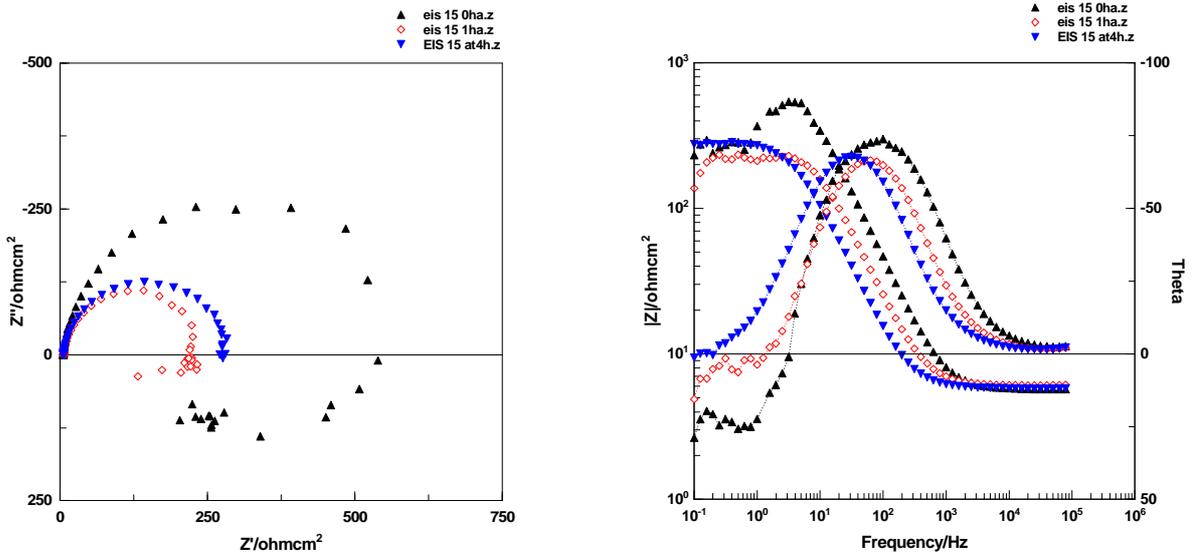
Figure VIII EIS results for an LM25 panel (0, 1 & 4 hrs) in Harrison's Solution, showing the Nyquist(left) and Bode(right) plots.

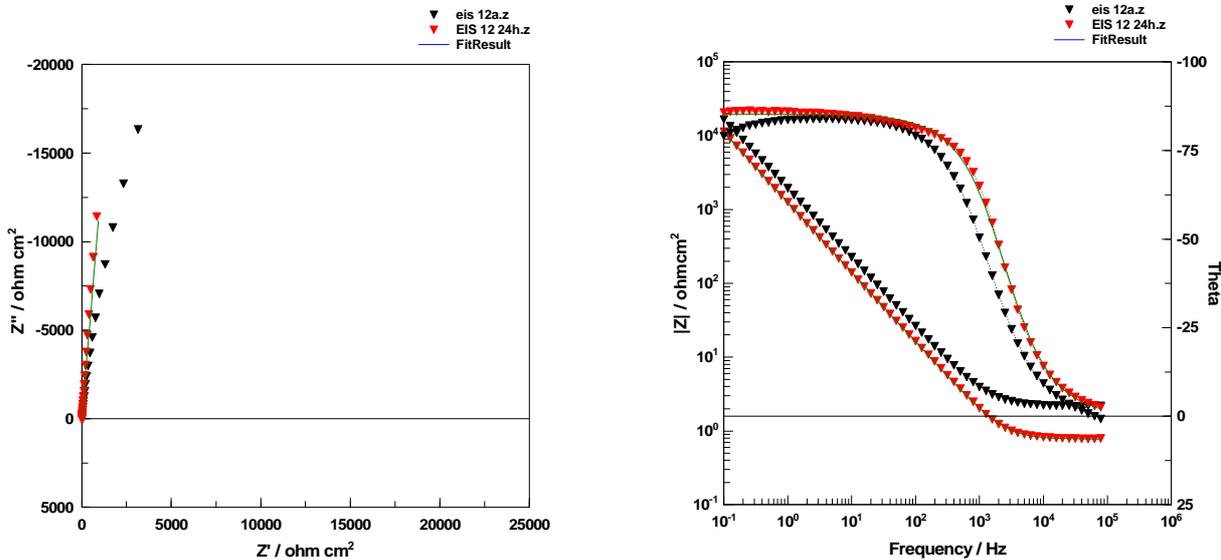
Figure IX EIS results for passivated 316L panel (0 & 24 hrs) in Harrison's Solution, showing the Nyquist(left) and Bode(right) plots.

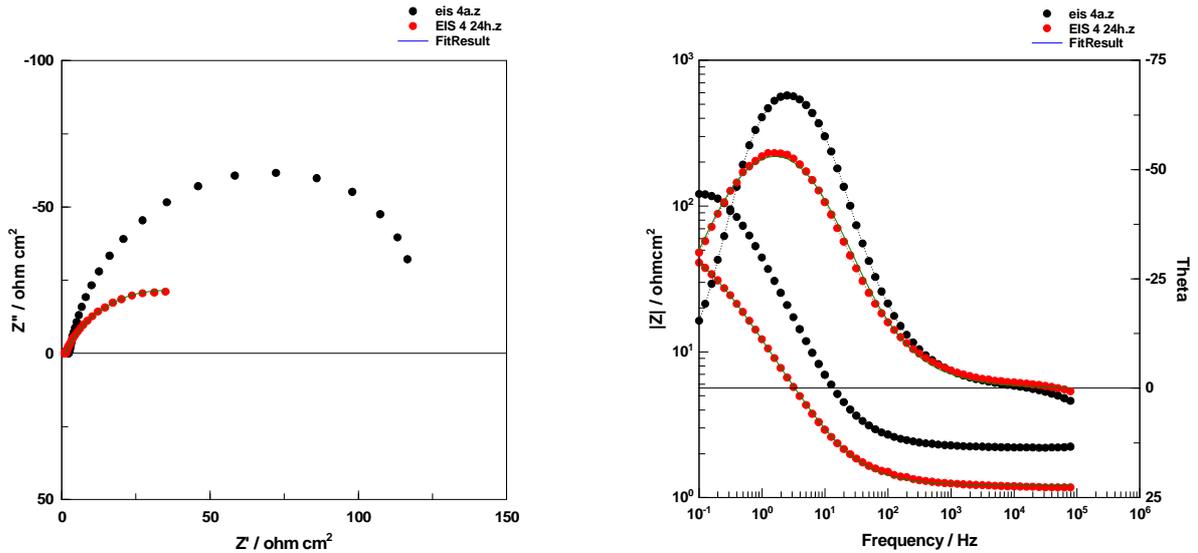
Figure X EIS results for SS317L(HVOF) coating (0, 2, 4, 6 & 30 hrs) in Harrisons Solution, showing the Nyquist(left) and Bode(right) plots.

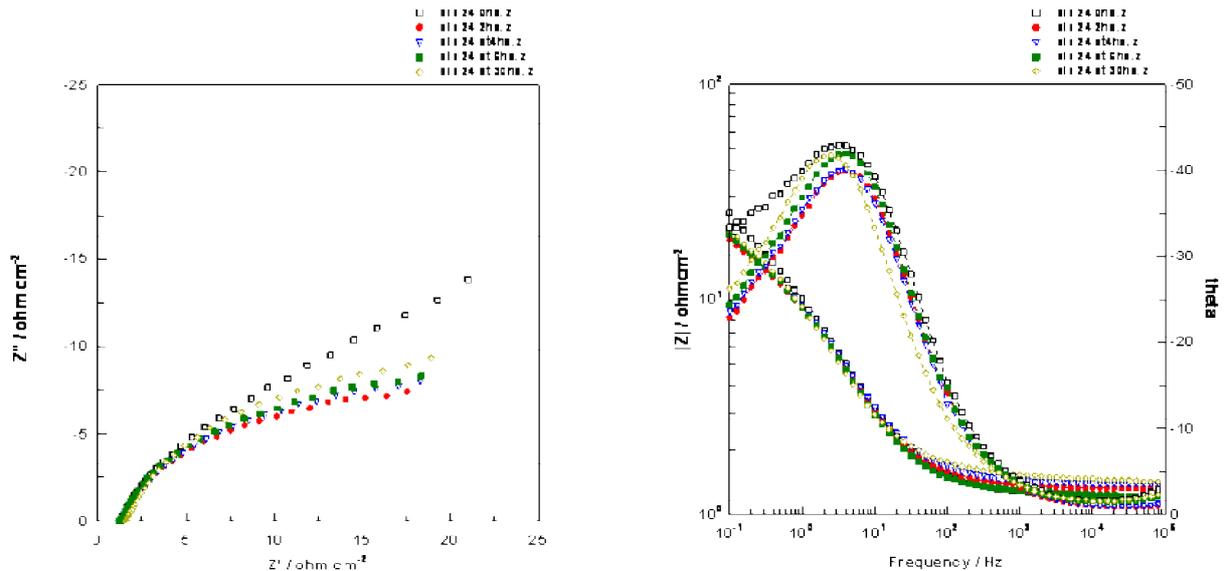
Figure XI EIS results for Inc.625(HVOF) coating (0, 2, 4, 6 & 30 hrs) in Harrisons Solution, showing the Nyquist(left) and Bode(right) plots.

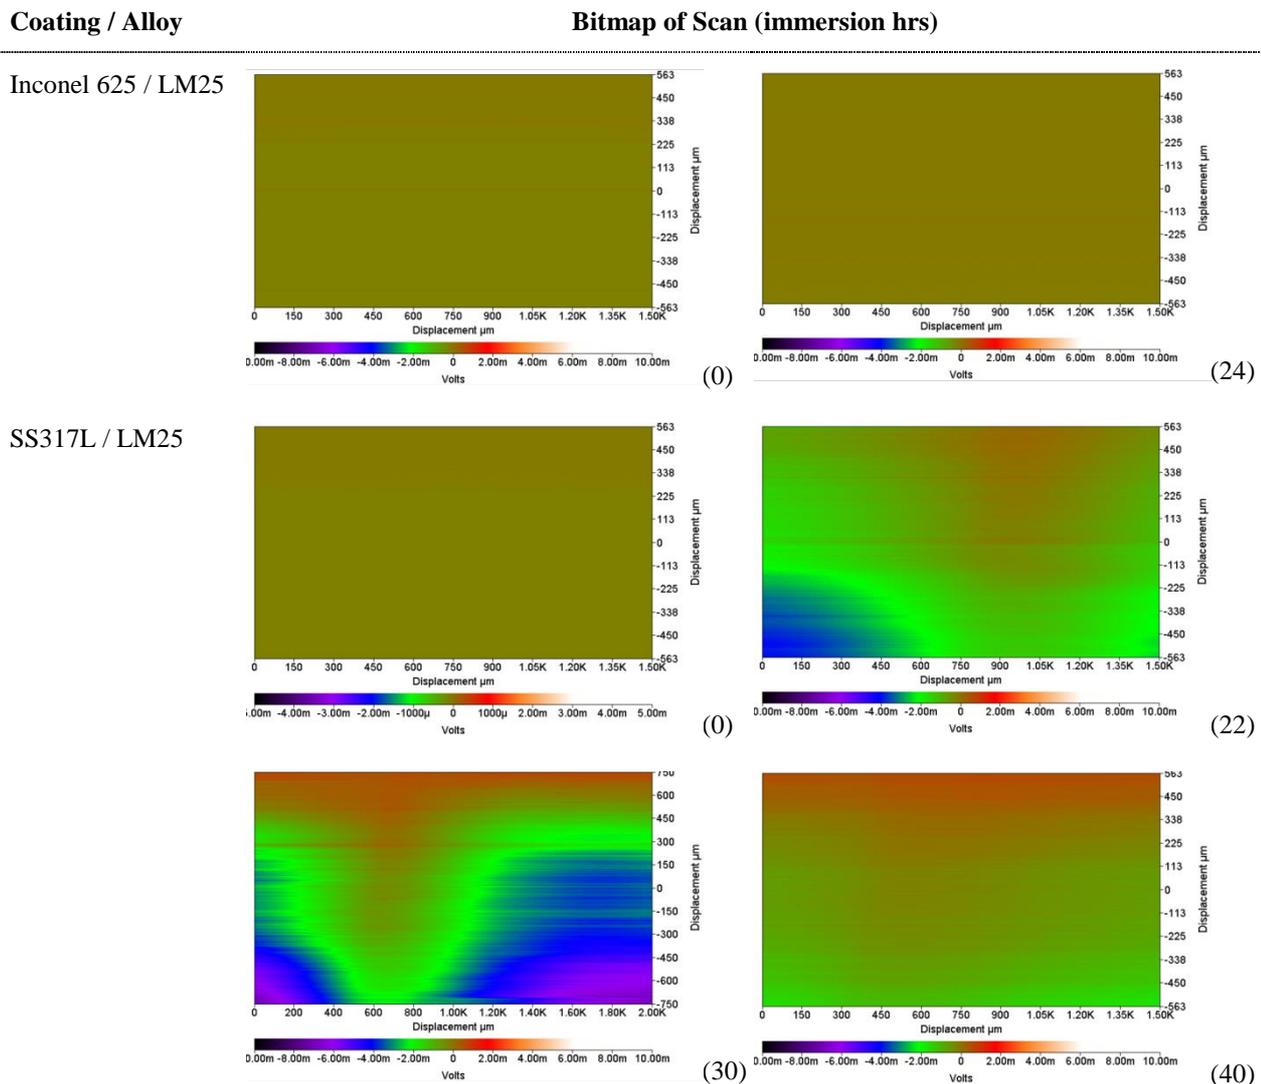
The results of the SVET testing are shown in Figure XII. Although the results are preliminary results, development of the cathodic and anodic areas are very apparent in the SS317L samples exposed to the NaCl/HCl solution. Over the period of the SS317L test the development of cathodic(blue) and anodic(red) areas around the coating / substrate interface is apparent. It can be seen in the latter scans that these areas not only develop but that the zones also move and disappear from the scan area. It has been reported by Akid et al<sup>20</sup> that the tendency for aluminium alloys to experience pitting corrosion cannot be measured easily by the standard SVET test. It is because of the tendency of the anodic and cathodic reactions to constantly move over the exposed surface areas that this is the case. It can be seen in the SS317L scans that the rate of growth of the cathodic and anodic areas correlates with the performance of the panels in the ASS environment, where corrosion product was noted on the

Figure XII Showing preliminary SVET Scans for Inconel 625 in 0.05M NaCl and SS317L in 0.05M NaCl/0.004MHCl.

panels within 24 hours of initial exposure. It is suggested, from the results of the EIS and cabinet testing that the corrosion of these hybrid systems is driven by the presence of more noble elements in the coating. The presence of through-pores exposes the substrate to  $Cl^-$  ions and creates a galvanic cell between the anodic substrate and the cathodic coating. These preliminary SVET scans would suggest that there is a strong tendency of these systems to form these galvanic systems but that the growth of corrosion product may have short-term benefits by restricting the limiting access to either the cathodic or anodic elements. From the 40 hour scan above it can be seen that, though the coating in this area is no longer acting as a cathodic element, there is still strong anodic activity at the substrate.

5. Preliminary results obtained from the SVP100 (SVET) analysis showed the development and movement of separate anode/cathode areas. These developments occurred within 20 hours of exposure to the corrosive environment, which correlates well with the performance observed in both the ASS test and the EIS.
