Microwave Self-healing Technology as Airfield Porous Asphalt Friction Course Repair and Maintenance System

Tabakovic, et al. (2019) Microwave Self-healing Technology as Airfield Porous Asphalt Friction Course Repair and Maintenance System'. *Case Studies in Construction Materials*, <https://doi.org/10.1016/j.cscm.2019.e00233>

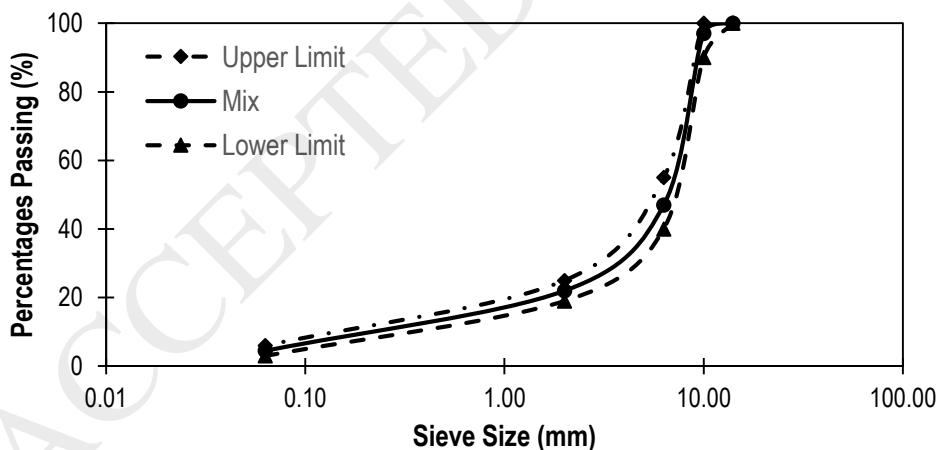
The Porous Friction Course (PFC) mix was prepared in accordance with MOD Specification 040. The aggregate was a high skid resistance Silurian greywacke from Northern Ireland. The filler was a combination of crushed Carboniferous limestone filler and hydrated lime to BS EN 459-1. The bitumen was a 160/220 pen as specified by MOD 040. Figure 1 shows the mix grading curve.

Figure 1. PFC grading envelope (MOD Specification 040).

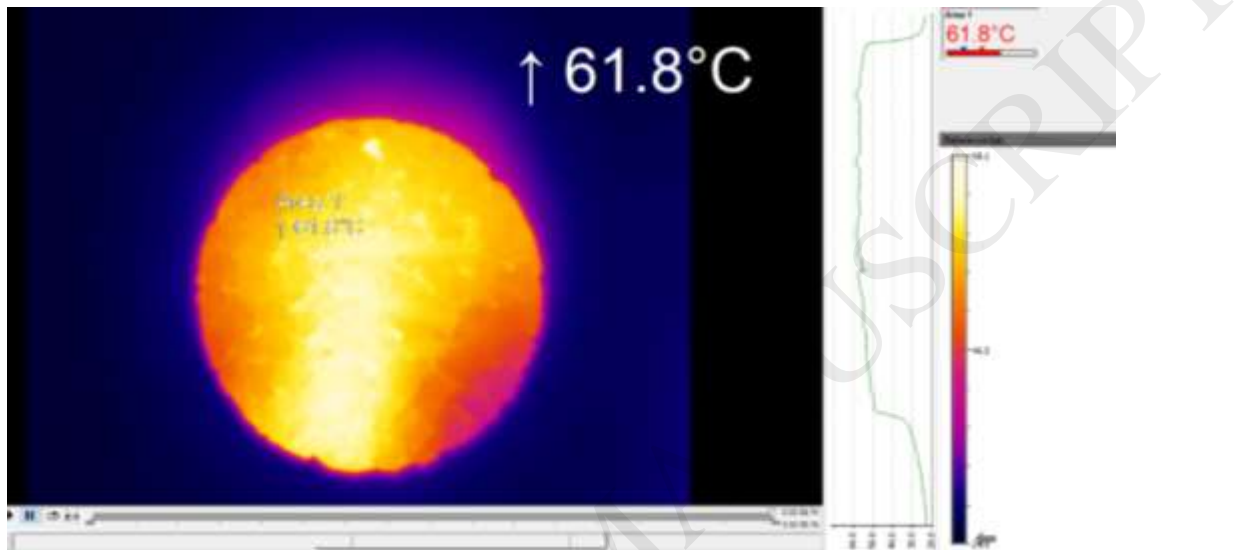
Thermal imaging was carried out to observe heat distribution throughout the test sample due to the microwave based healing process. This used a Micro Epsilon ThermoIMAGER TIM 400. Recording began immediately after the plastic collar was removed from the micro-wave heated specimen. Figure 4 shows a thermal image of a test specimen 60 seconds after microwave heating. The image shows temperature distribution across the surface of the test specimen. The average temperature is 61.8°C ranging from 56°C at the edges of the test specimen to 66°C at its centre. Figure 4 shows that this elevated temperature is relatively evenly distributed across the surface suggesting good steel fibre distribution throughout test specimen and in turn good asphalt mix healing.

Figure 4. Example PFC test specimen thermal image 60 seconds after removal from microwave.

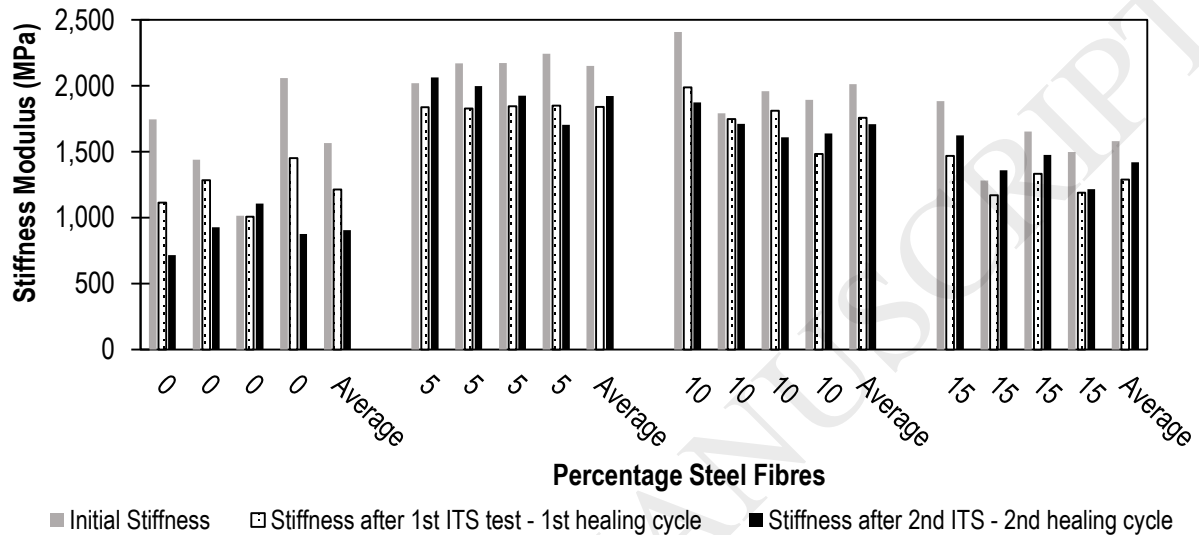
Figure 5 plots the ITSM test data. This shows a significant improvement in ITSM between the control PFC mix containing no steel fibres and the PFC mix containing 5% steel fibres. The addition of 10% and 15% steel fibres caused a reduction on ITSM values compared to the 5% PFC mixes.

Figure 5. ITSM data

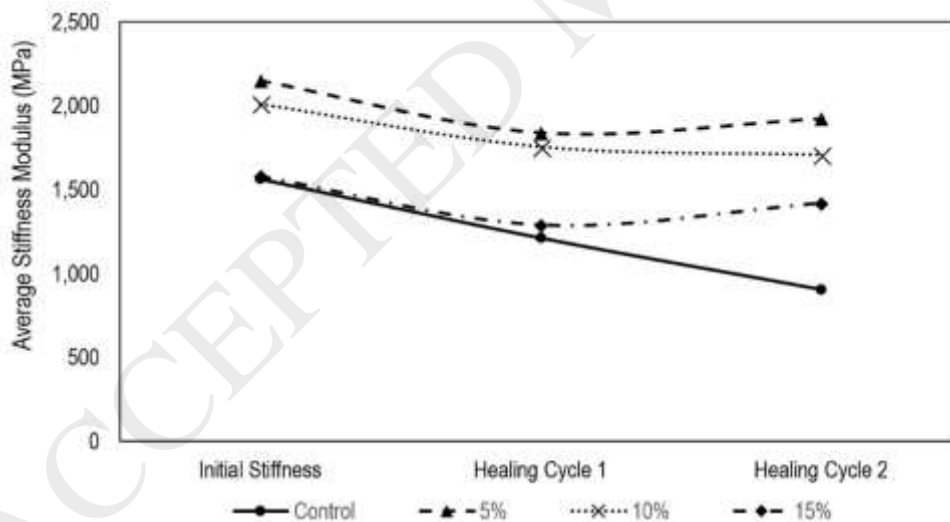
Figure 6. Averaged ITSM data.

Figure 6 plots the average ITSM data for the initial testing and then after 2 rehealing periods simulating 2 periods of simulated crack treatment. This shows a gradual linear stiffness decrease for the control mix with a significant deterioration in stiffness given by an ISTM ratio of 0.58. The results show that the control samples with no steel fibre have no stiffness recovery. The PFC mixes containing steel fibres show better initial ITSM compared to the control. As the specimens are cracked and healed there is a reduction in stiffness after the first re-healing cycle. The data shows the ITSM to either

remain the same or to slightly improve after the second re-healing cycle. After the second re-healing cycle the PFC specimens containing 5% steel fibre have approximately twice the ITSM of the control PFC containing no steel fibre. Whilst this is a simple laboratory investigation the implications of this are significant for maintenance of an airport runway.

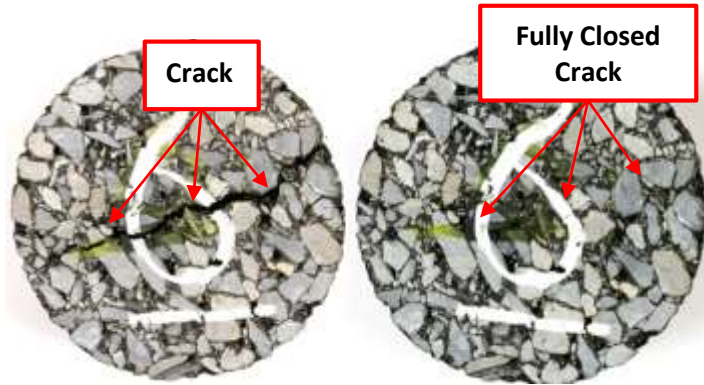
The PFC test specimens with 5% steel fibres increased stiffness value after the healing cycles. Figure 12 shows PFC sample #6 containing 5% steel fibres before and after healing cycle 2. Compared to Figure 11, the crack is completely healed. The increase in heat has probably reduced binder viscosity allowing it to flow not only into the visible cracks but also into other microcracks within the specimen. This agrees with the major healing mechanism of induction healing being capillary flow [23] and diffusion of the asphalt binder at high temperatures. Figure 13 shows PFC sample #15 which contains 15% steel fibres. The crack is fully repaired.

Figure 12. PFC specimen #6 with 5% steel fibre: Left: before healing and Right: after healing with fully repaired crack.
