An Ergonomic Assessment of a Customer Service Organisation

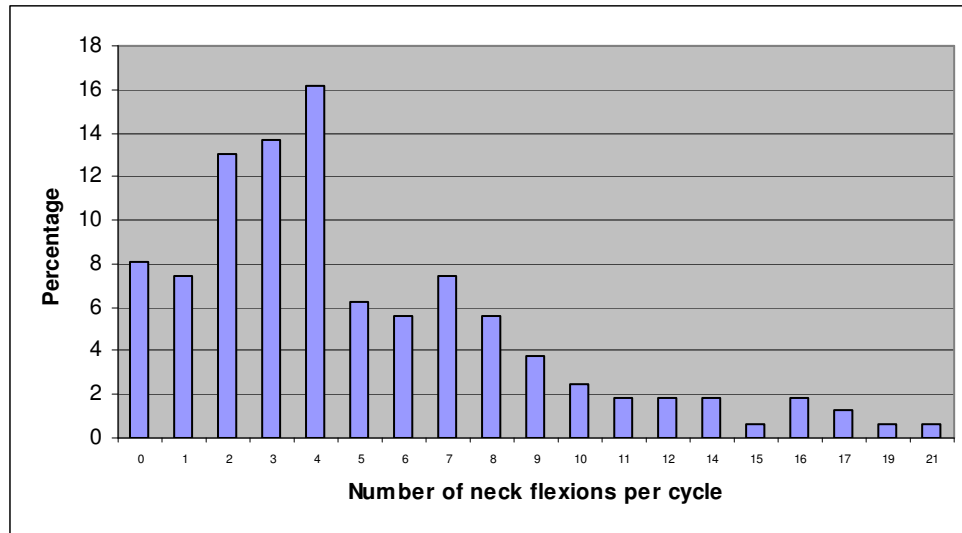
Figure 1.2 Frequency of neck flexions* per task cycle**

results found is shown in figure 1.2 below, detailing the number of neck flexions per adopted by staff member when dealing with customers.

* The neck flexion position was noted with the head facing downwards.

**The task cycle is the time taken for the employee to deal with the customer from start to finish.

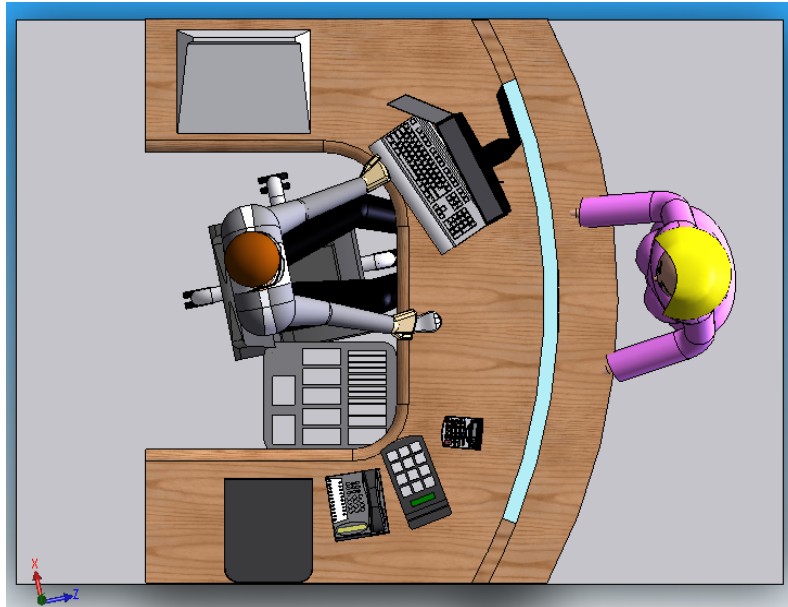
Figure 1.3: Redesigned Workstation Layout

The existing design of the workstation was less than ideal for the tasks being carried out. All equipment was located on one side of the workstation and the visual display monitor was positioned too high and too far to one side for comfortable use. This layout contributed to unnecessary neck movements and stretching of arms.

Recommendations to improve the layout included redesigning the area to use both sides of the workstation and adopting a semi-circle work area around the operator. A computer aided design package was used to create a number of possible remedies to the existing workstation. Figure 1.3, illustrates one of the possible redesigns, which complies with ISO 9241. A document holder and footstool is also designed in. All equipment in the new design is now shown as placed within easy reach of each user.
